## Rapid Hazard Assessment Report

Location: Kunwari, Chamoli, Uttarakhand

Date: May 2022 – November 2024 (ongoing)

Hazard type: Landslide, landslide dammed lake

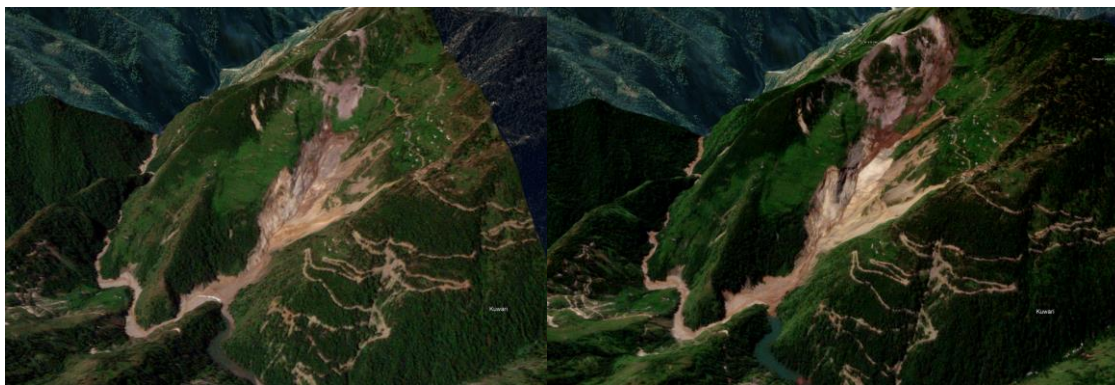
चित्र 2: 9 जुलाई (बाएं) और 31 अगस्त (दाएं) 2024 के बीच ढलान में हलचल। यह भी ध्यान दें कि उस दौरान झील कैसे बढ़ी है।

घटनाओं के बार-बार होने की संभावना: यह संभावना है कि ढलान पर हलचल जारी रहेगी और 2025 के मानसून के दौरान फिर से गति पकड़ लेगी, तथा बड़े पैमाने पर हलचल के कारण झील का आकार और भी बढ़ जाएगा।

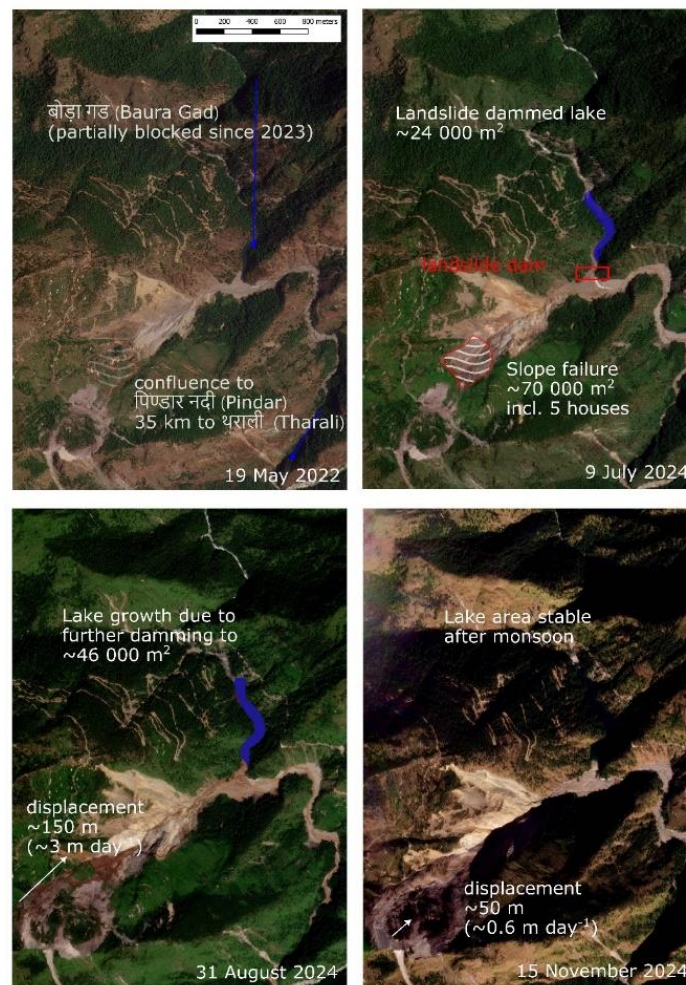
Figure 1: Development of the slope failure since 2022, with the formation of a lake after landslides in 2022, with another significant mass movement during monsoon 2024.

After an initial landslide in 2013 at Kunwari Village, repeated landslides until 2022 caused the Baura Gad (also known as Shabhu or Shambhu Gad) to dam repeatedly with subsequent drainages<sup>1,2</sup>. Landslides in 2022, which took away at least 5 houses of the Kunwari Village, caused the lake to form again to a size of 24000 m<sup>2</sup> (by July 2024), which subsequently did not drain anymore (Bisht et al., 2022). By August 2024 the lake had grown to twice the size and displacement of the landslide over two months was 150 m. Between August and November 2024 the lake growth has ceased (but due to the massive debris deposits has also not decreased in size likely due to increased blockage), however displacement has continued by another 50 m. InSAR analysis conducted using Sentinel-1 data acquired from ascending orbits suggests

**Impact:** The initial landslide has caused a lake to form before 2022, which repeatedly drained. Since 2022 drainage is no longer possible and it has increased in size by November 2024. Large parts of the Kunwari Village have been destroyed and are likely to continue to be affected in the coming months.
