## द्रुत खतरा मूल्यांकन प्रतिवेदन

## Rapid Hazard Assessment Report

Location: Lirung massif, Lendhe Catchment, Upper Trishuli Watershed

Hazard type: rock-ice avalanche, flood

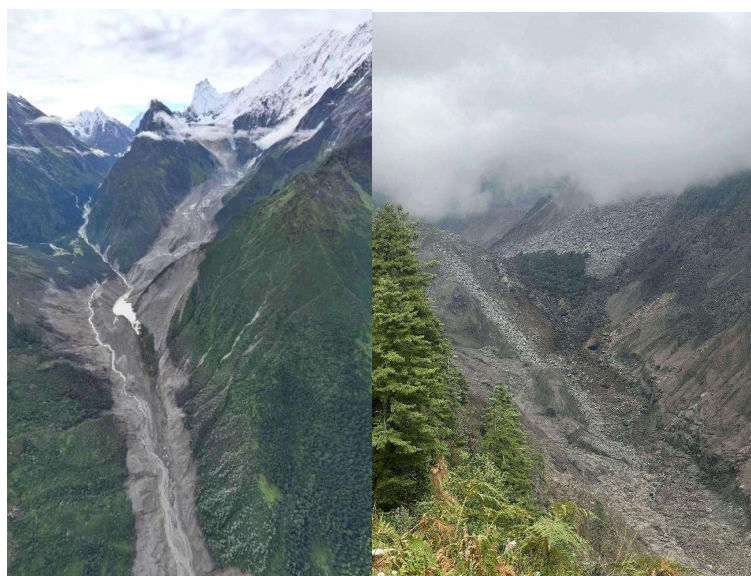
चित्र ३: घटनापछिको स्रोत क्षेत्रको तस्वीर (बायाँ) र विफलतापछिको अन्तिम निक्षेप (दायाँ)। नोट: तालमा अझै केही पानी बाँकी रहेको छ।

घटना भएको केही समयपछि उपग्रह तस्वीर (Planet, Landsat 9) ले हिमनदीको भाग (RGI2000-v7.0-G-15-05732), साथै अझै अज्ञात, तर स्पष्ट रूपमा उल्लेखनीय, गहिराइमा तलको आधारशिला लगभग १ देखि १.३ किलोमिटर चौडाइमा छुट्याइएको खुलासा गरेको छ, जुन लगभग ५२०० मिटर ए.एस.एल. को उचाइमा रहेको छ, जसले गर्दा हिमनदीको अगाडिको भागमा सामग्री परिचालन हुँदै ३००० मिटर ए.एस.एल. भन्दा तलको उपत्यकाको भुइँमा पुग्यो (चित्र २)। यहाँ ठूलो प्रवाह २०२५ मा पुरेपु (GLOF- हिमताल फुटेर आएको बाढी) घटनाबाट निक्षेपहरूसँग भेट भयो (Zhang et al., 2026) र लेन्ड ए खोलामा बाँध बनायो, सम्भवतः केही मिनेटको लागि मात्र। बाँधको अन्ततः विफलताको परिणामस्वरूप बाढी आयो जसले चीन र नेपालमा ठूला तल्लो तल्ला क्षेत्रहरूलाई असर गर्यो। स्रोत क्षेत्रका तस्बिरहरूले यी अवलोकनहरूलाई पुष्टि गर्दछ (चित्र ३)।

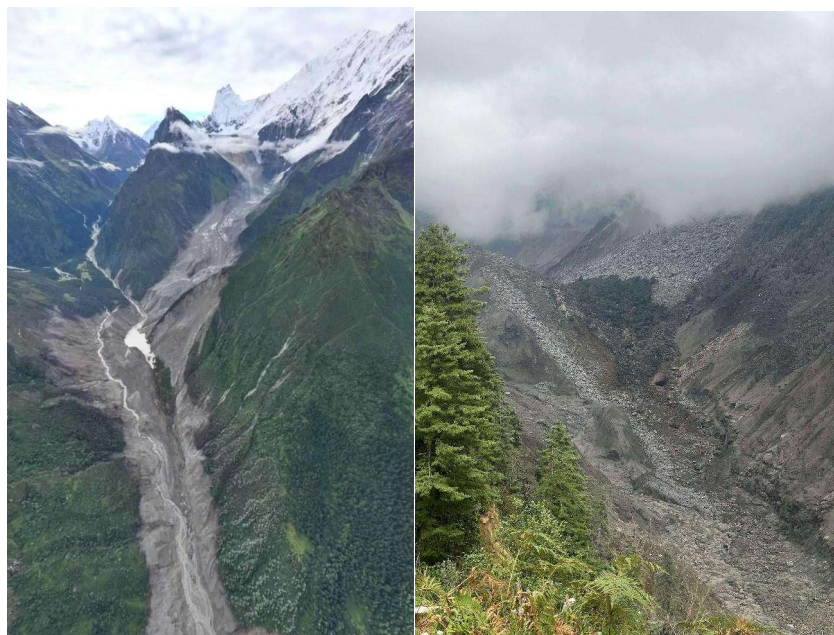
Figure 3: Photographs of the source area after the event (left) and the eventual deposit (right) after failure. Note that some water remains in the lake.

Satellite imagery (Planet, Landsat 9) just after the event revealed that part of a glacier (RGI2000-v7.0-G-15-05732), as well as the underlying bedrock down to a yet unknown, but apparently significant, depth had detached across a width of approximately 1 to 1.3 kilometers at an elevation of approximately 5200 m a.s.l., mobilising material in the proglacial terrain along its way and reaching the valley floor just below 3000 m a.s.l (Figure 2). Here the mass flow met with deposits from the Purepu GLOF event in 2025 (Zhang et al., 2026) and caused the Lhende Khola to dam, potentially only for a matter of minutes. The eventual failure of the deposit resulted in the flood that impacted large downstream swaths in China and Nepal. Photos from the source area confirm these observations (Figure 2 and 3).

Small lake drainages, from legacy lakes (Figure 2, 3) occurred already on the 28th of August and will possibly continue, are only potentially hazardous if material from further up on the glacier collapses into them.
